INSTALLATION RESTORATION PROGRAM

SOUTH DAKOTA NATIONAL GUARD
JOE FOSS FIELD, SIOUX FALLS, SOUTH DAKOTA

SITE INVESTIGATION REPORT

February 1996

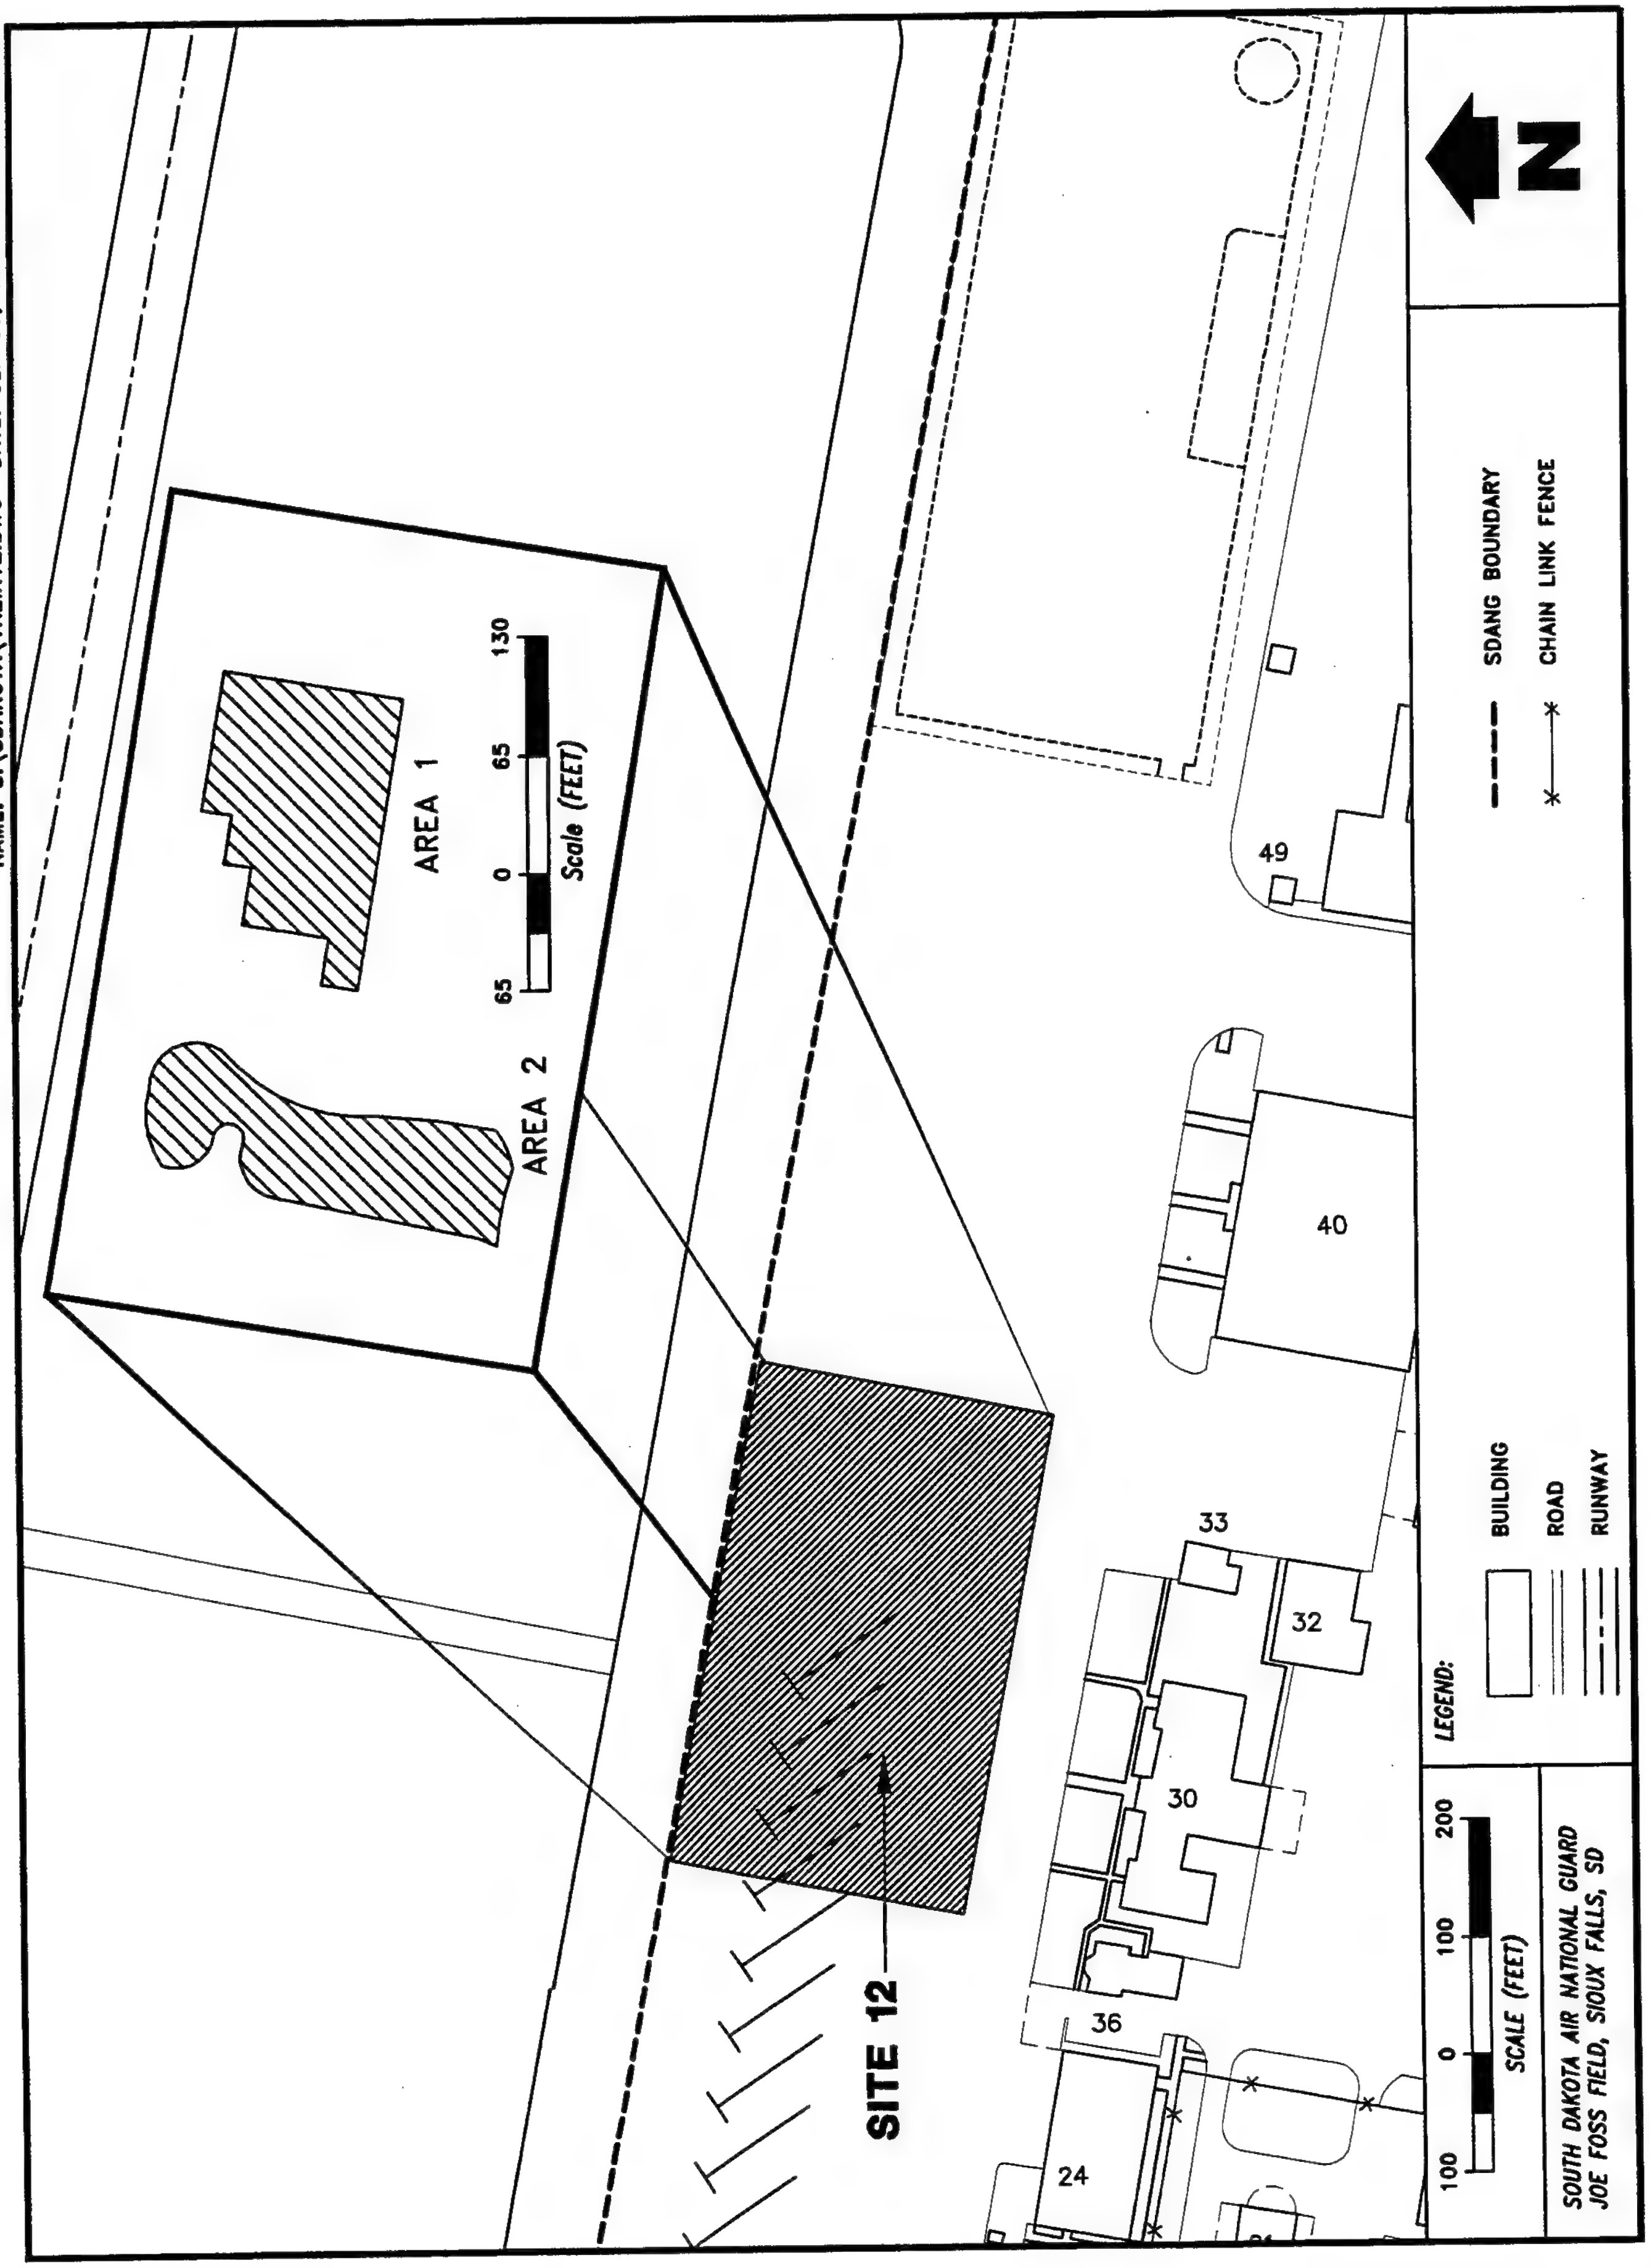
Figure 2-1. Location of Areas 1 and 2 within Site 12

project in 1993, consisting of removing selected areas of the existing concrete parking apron and taxiway, preparing the subgrade, installing an underdrain system, and replacing the concrete pavement. Following removal of the existing concrete pavement, construction personnel noted petroleum odors in two areas (designated Areas 1 and 2). The location of these areas in relation to existing structures is illustrated in Figure 2-1. Area 1 is located north of Building 30 and Area 2 is located west of Area 1. Soil contamination was observed along the expansion joints using a photoionization detector (PID). Soils were excavated to a depth of 8 feet below land surface (BLS) at Area 1 and 3 feet BLS at Area 2. The excavation depth was determined based on field screening of soil samples for organic vapors using two PIDs. At both Areas 1 and 2, the soil contamination was localized and varied with depth (e.g., Area 2 PID data indicated contamination at ½ foot depth (375 ppm) and no contamination at depths of 1, 2, and 3 feet BLS). At Area 1, organic vapor concentrations at a depth of 8 feet BLS ranged from nondetect (ND) to a maximum of 353 ppm (Geotek 1993). Approximately 1,524 tons of petroleum-contaminated soils were removed and transported to the Runge Landfill in Sioux Falls, South Dakota.

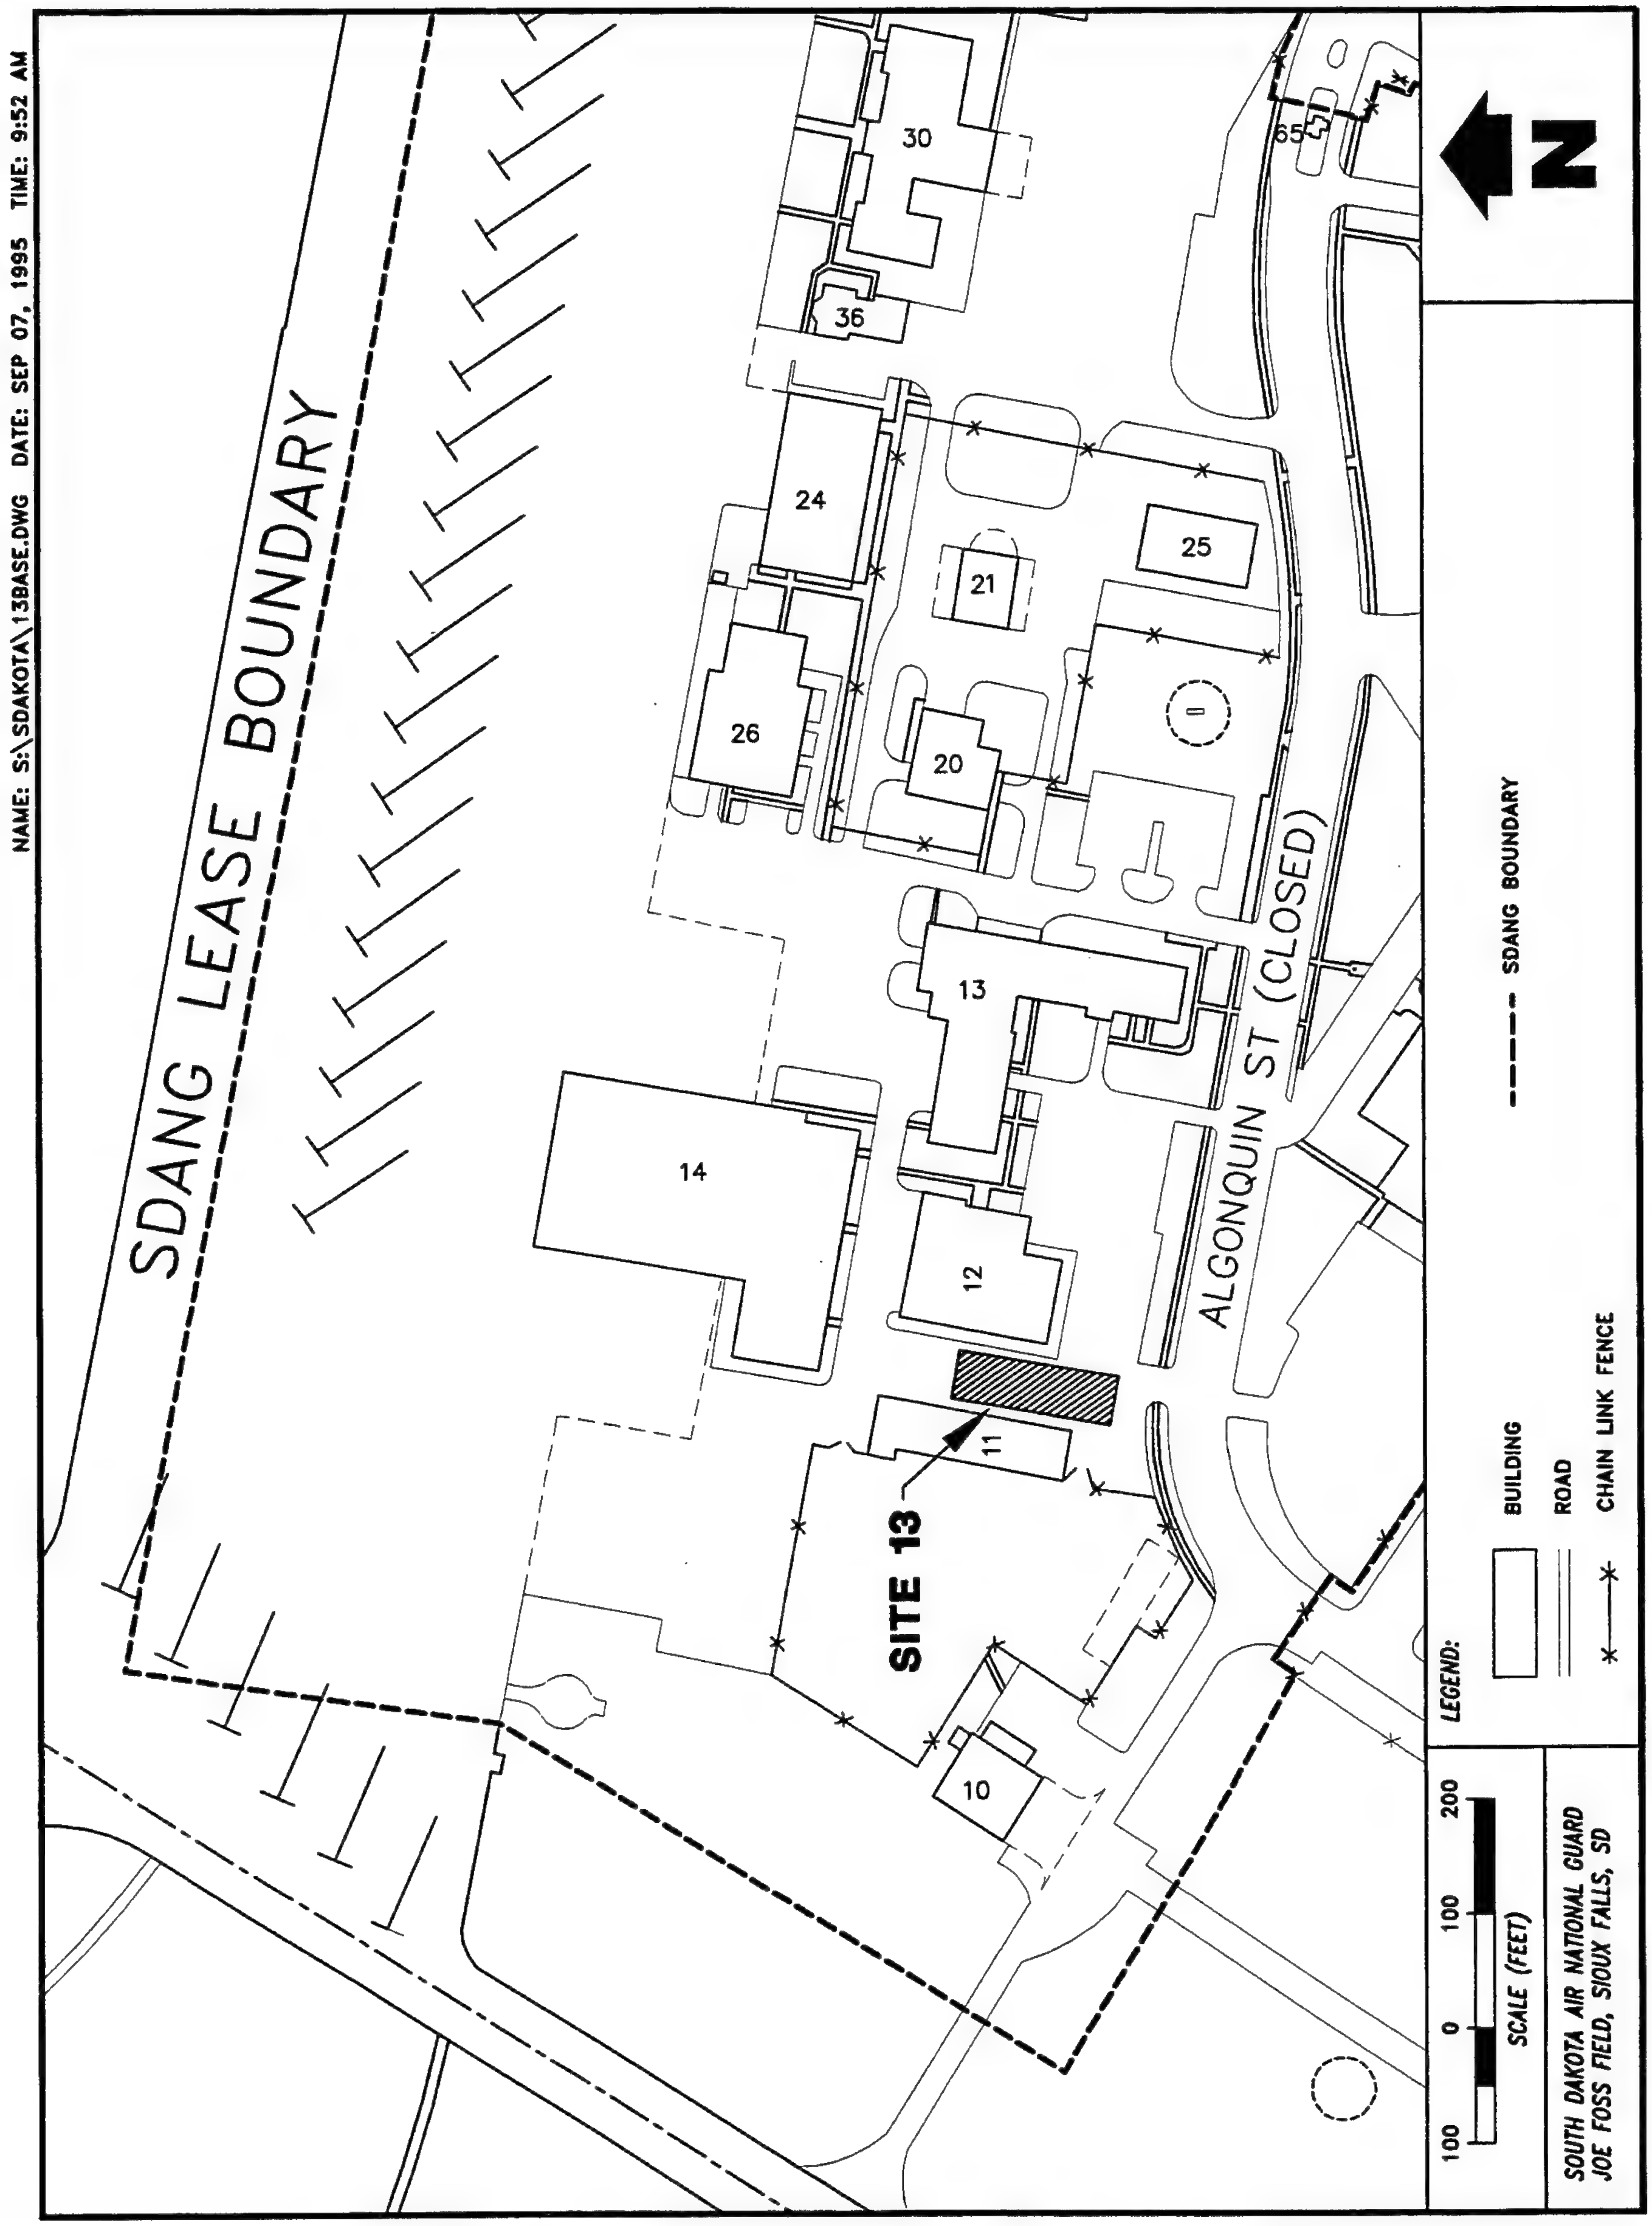
Figure 2-2. Location of Site 13

Site 13 - MVMF was constructed in 1976 and consists of an Automotive Maintenance Shop (Building 11) and a fuel dispensing station located east of Building 11, as shown in Figure 2-2. The facility consists of three 2,000-gallon above-ground fuel storage tanks, which are located south of Building 11. The buried fuel lines from the tanks to the dispensing pumps were tested for leaks in May 1993 and August 1994. On both occasions, the lines passed the leak detection test (SAIC 1995). The area around the fuel dispensing island is paved with asphalt. Soil contamination was first observed when concrete posts were being installed around the fuel dispensing island in July 1994.

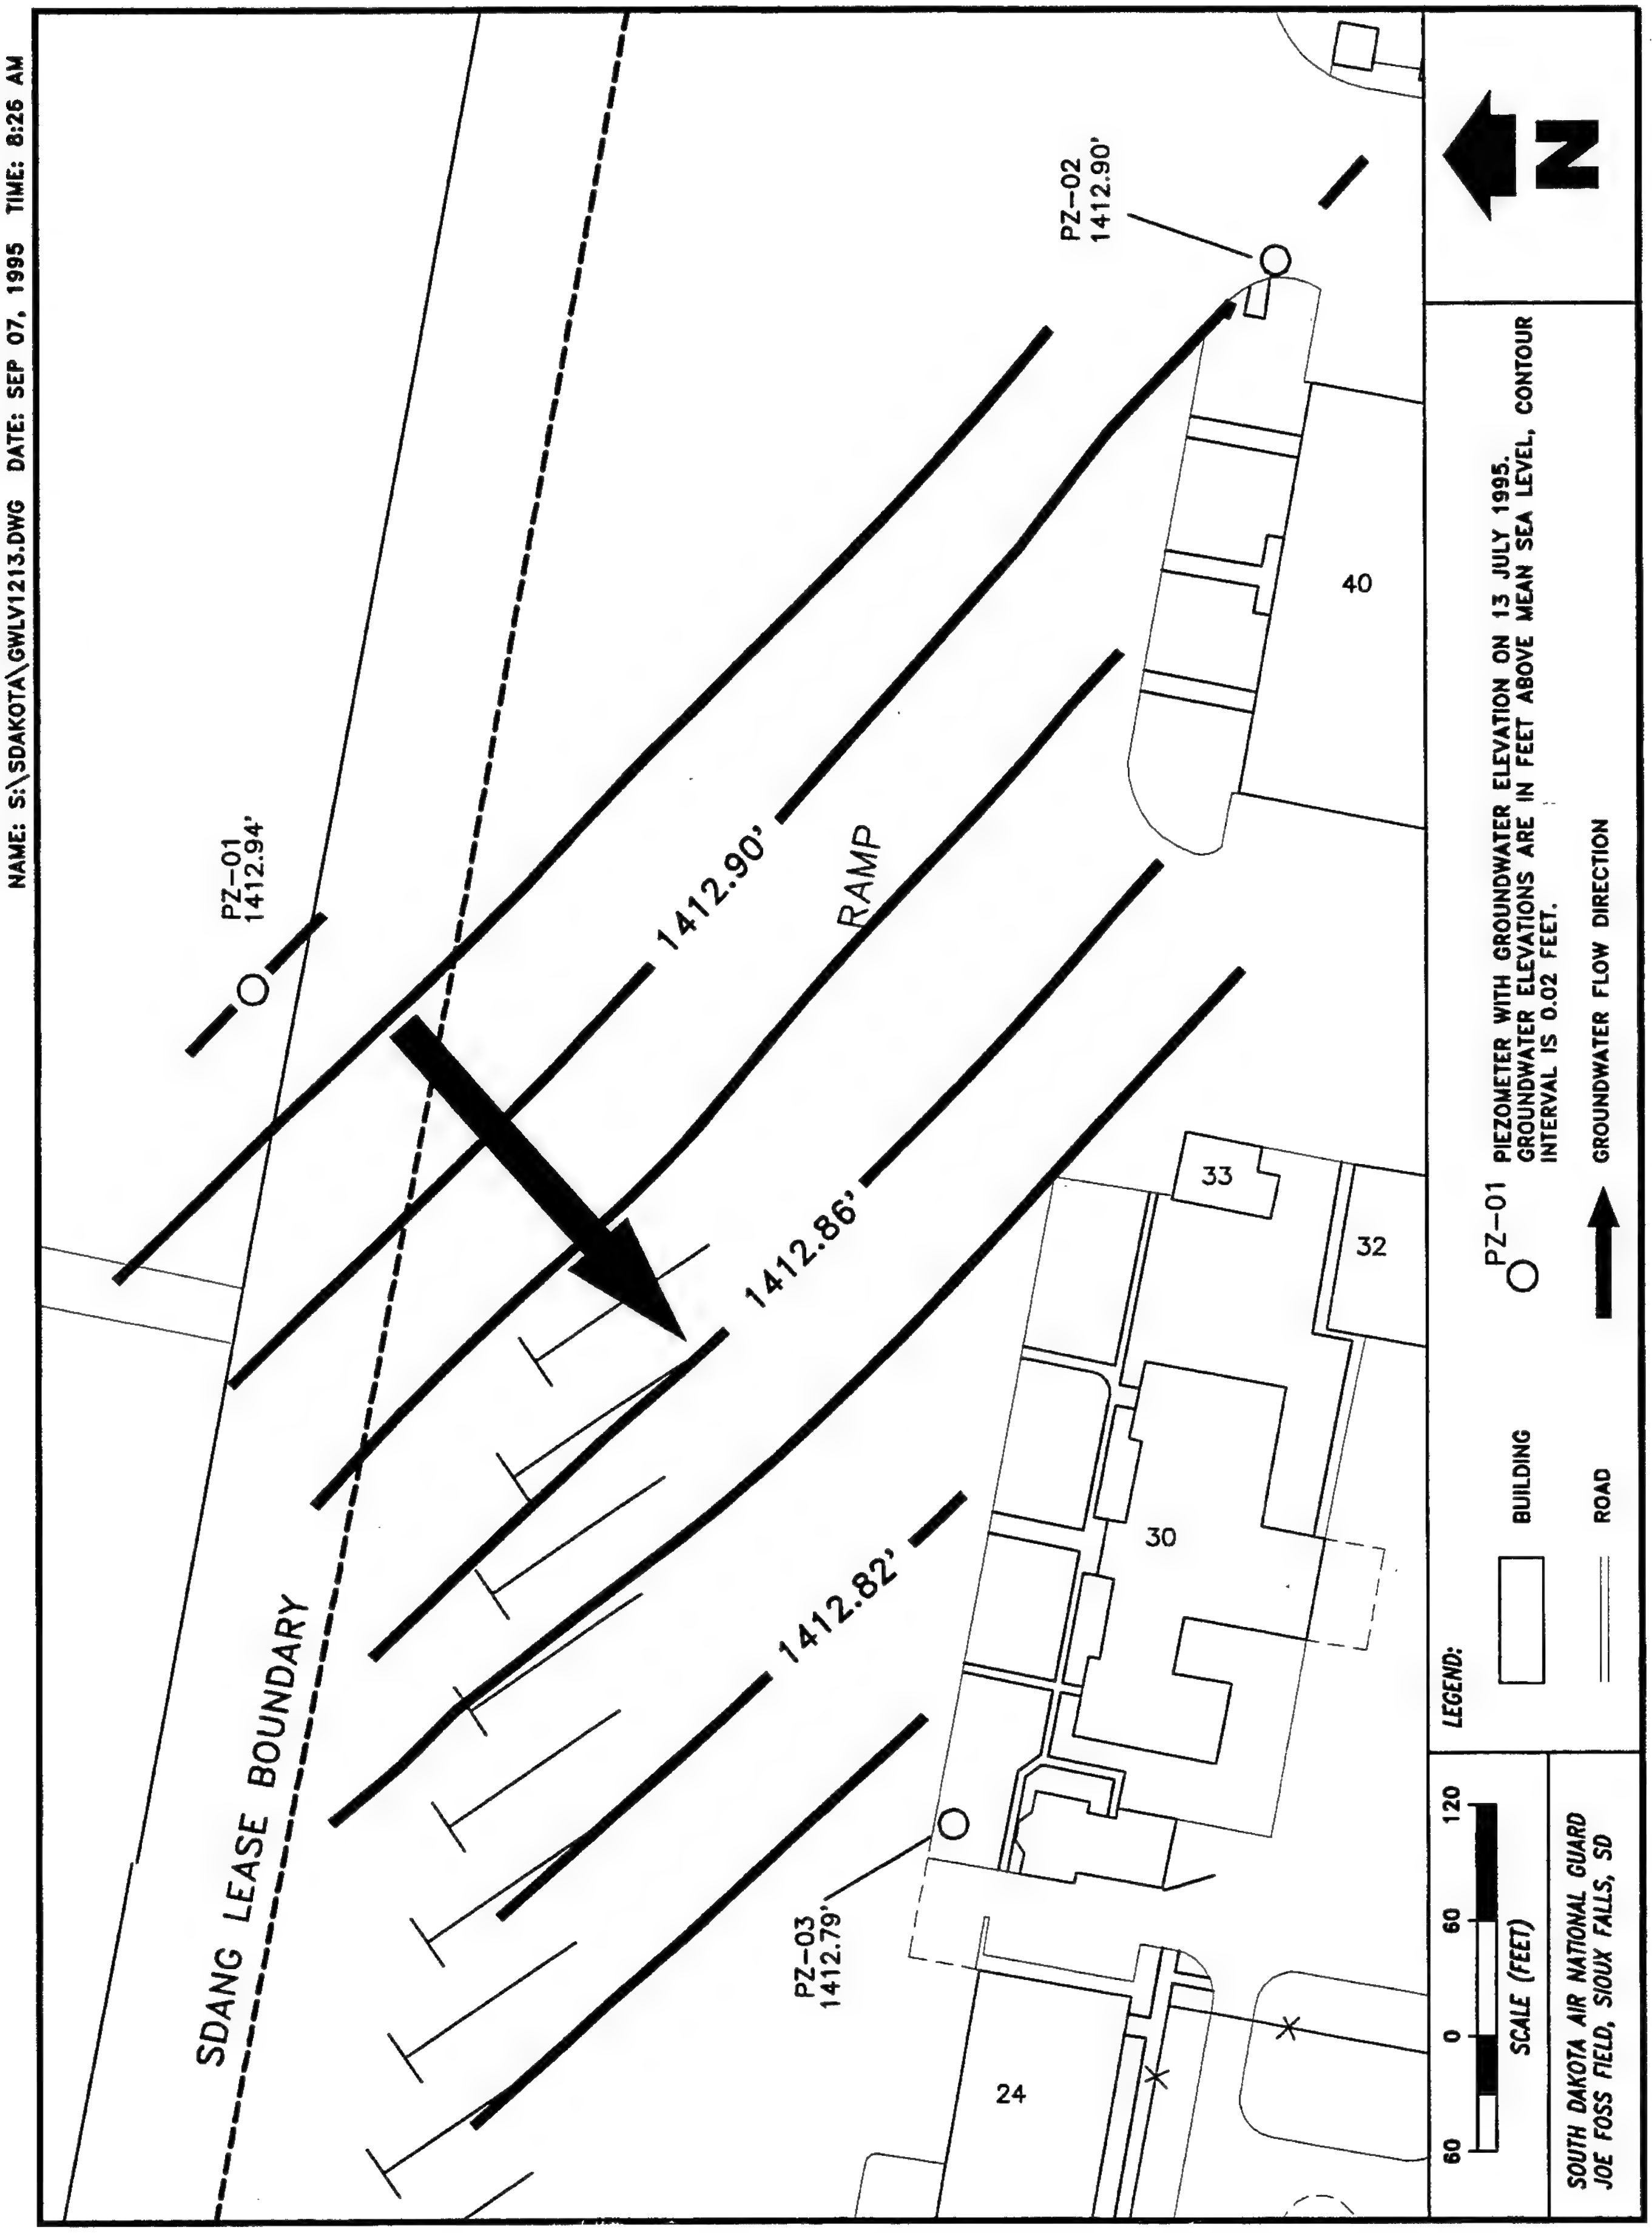
Figure 3-6. Groundwater Levels in Piezometers at Site 12 on 13 July 1995

During piezometer and monitoring well installations within Sites 12 and 13, static water levels ranged from approximately 6 to 7 feet BLS, as shown in Figure 3-6. Flow direction determined using data from the three newly installed piezometers at Site 12, was to the southwest.

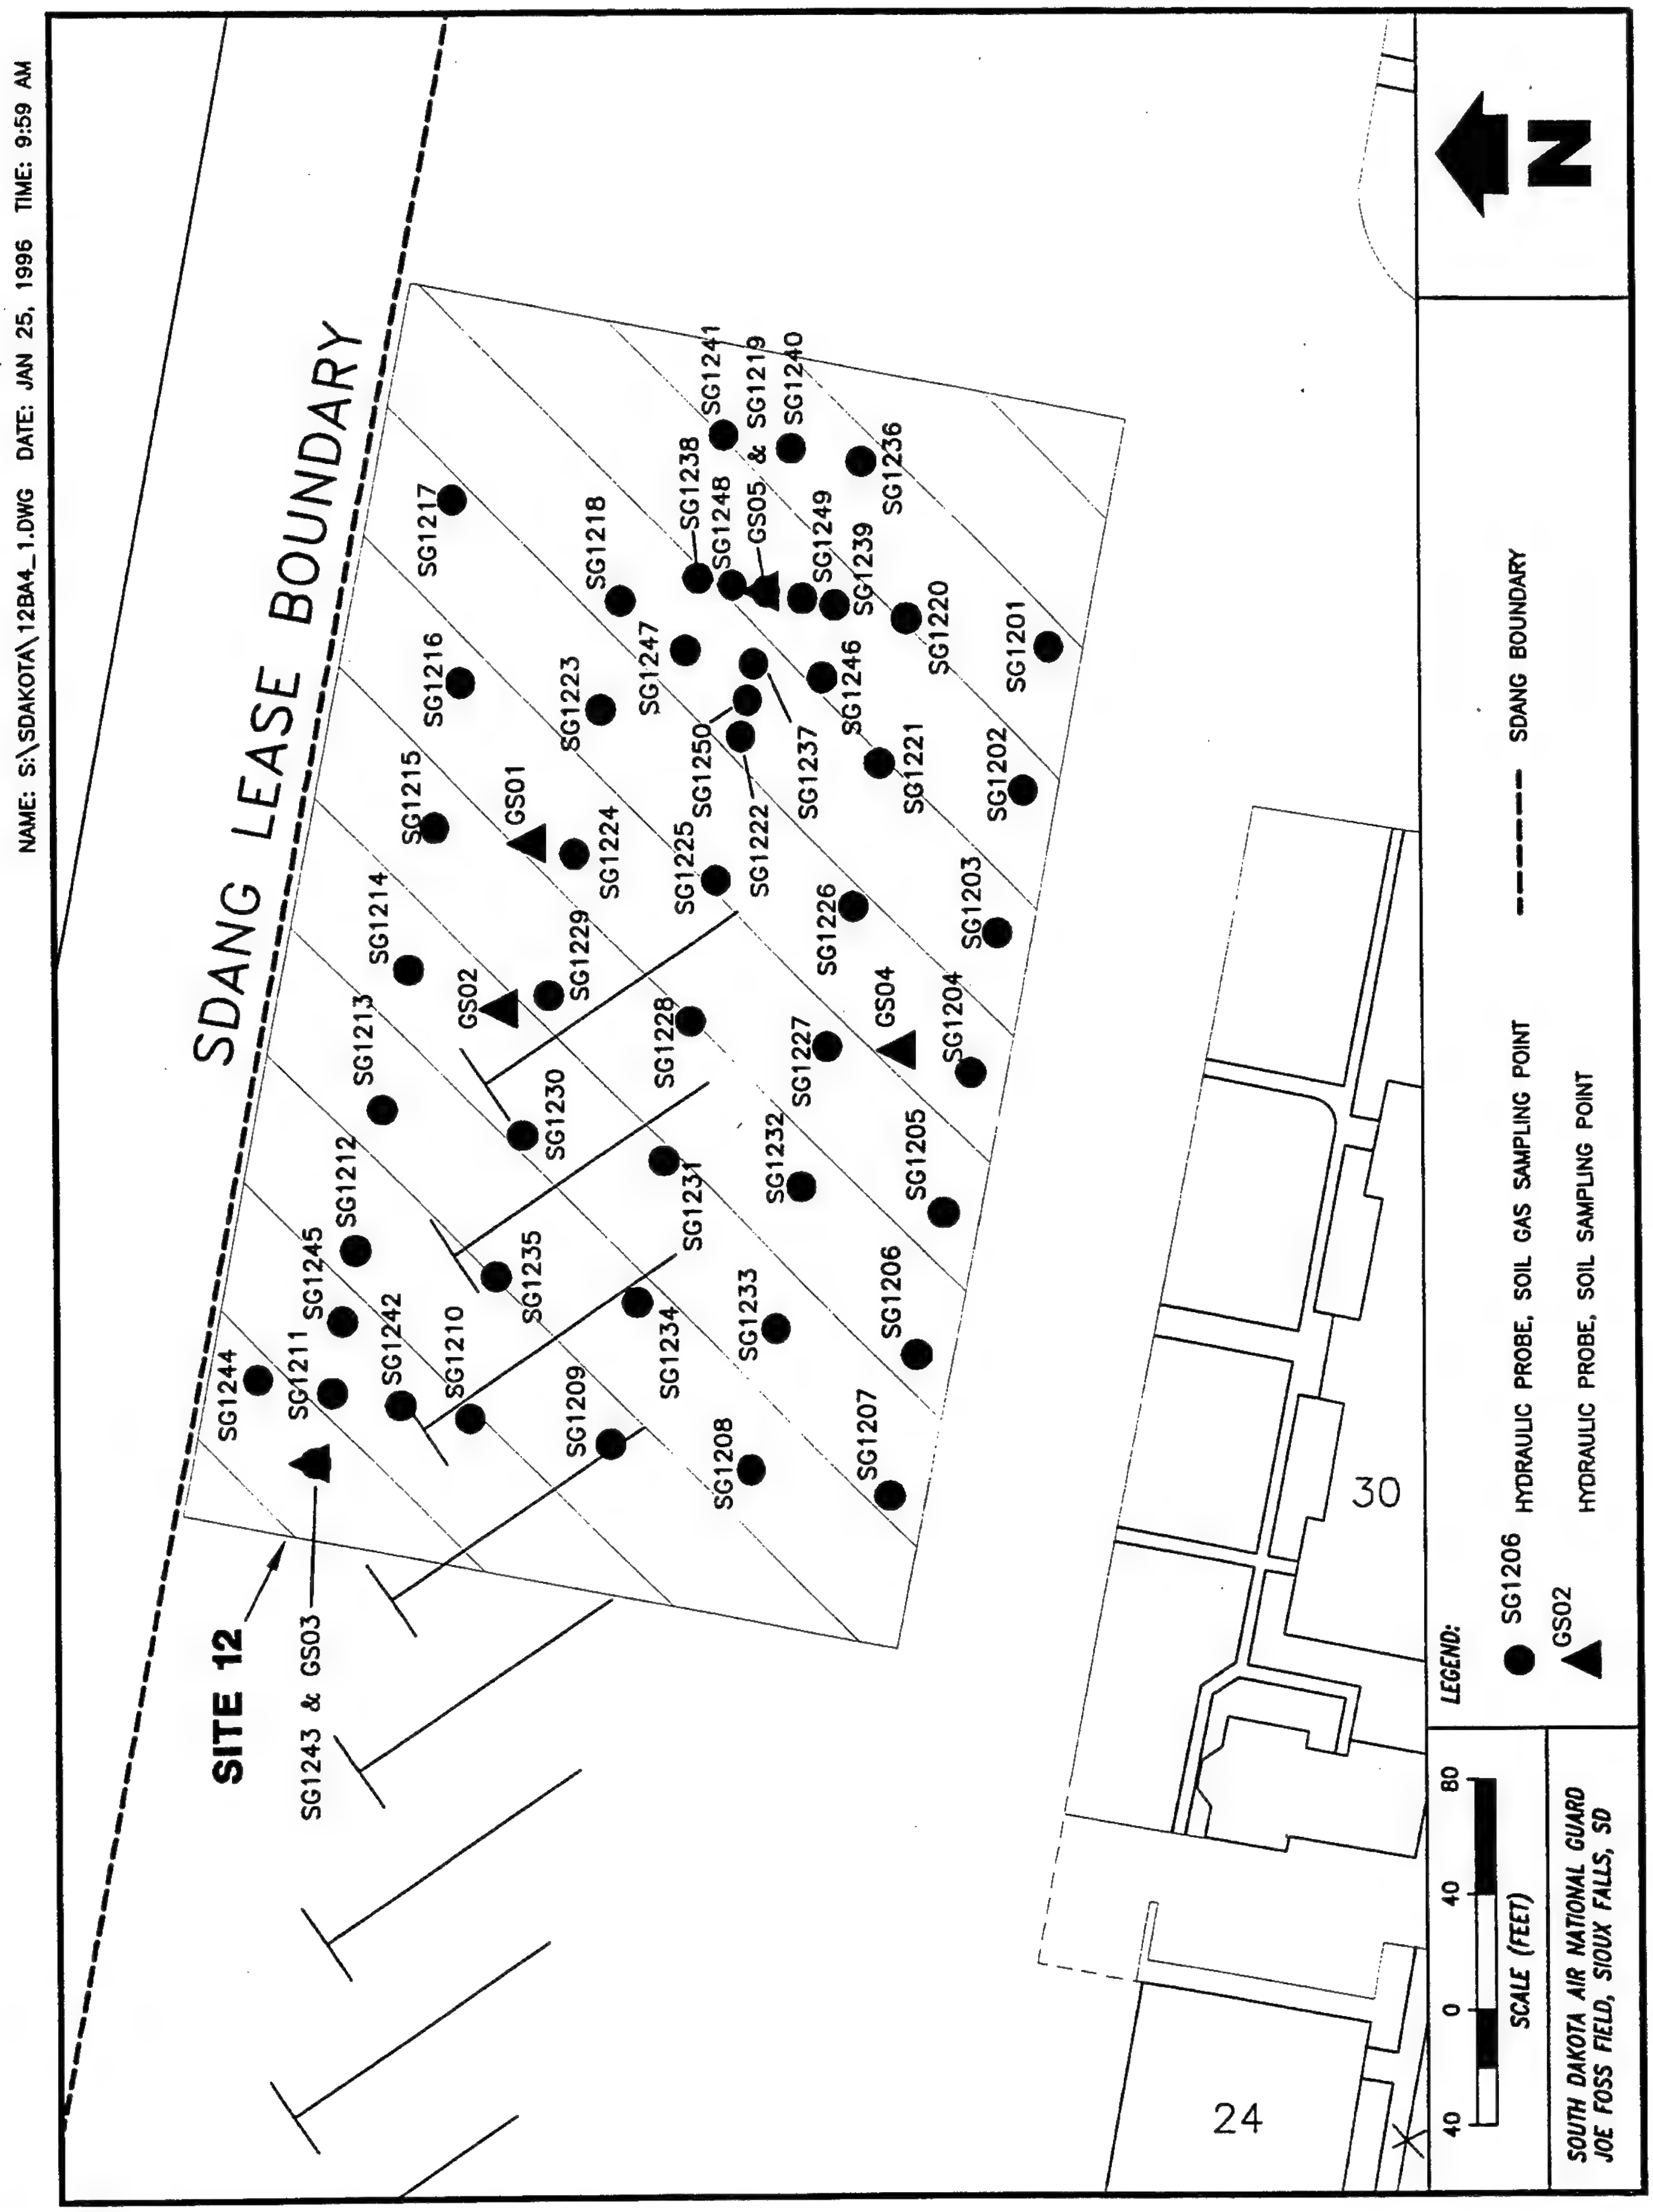
Figure 4-1. Field Screening Sampling Points at Site 12

Based on the screening results of the original 35 SOV points, 15 points were added to better define the potential contaminant source areas. Four additional points were located around point GS12-11, where total xylenes were detected (the concentration was below reporting limits). Eleven additional points were located around GS12-19, which was the only other point of the original 35 where contaminants were detected. Additional points were first located 25 feet from GS12-11 and GS12-19. If contaminants were not detected at this position, another sample was taken 12.5 feet from the original location where contaminants were detected. Contaminants were detected west of GS12-19, at grid point GS12-37. One additional sample was collected 12.5 feet to the west of GS12-19. Two samples were taken 25 feet from GS12-37, one to the north and one to the south. Three SOV sampling points were located 50 feet east of GS12-19—one point was located directly east, and the other two were located 25 feet north and south of GS12-19. A buried water line 25 feet east of GS12-19 interfered with SOV sampling at that location.

At each sampling point, three SOV samples (at 2, 4, and 6 feet BLS) were collected. The first sample was collected at a depth of 2 feet BLS due to the thickness of the concrete (8 to 16 inches) and the gravel underneath. Groundwater was encountered at approximately 7 feet BLS, which prevented SOV sampling at depths below the 6-foot interval. The SOV survey results are discussed in their entirety in Appendix A.

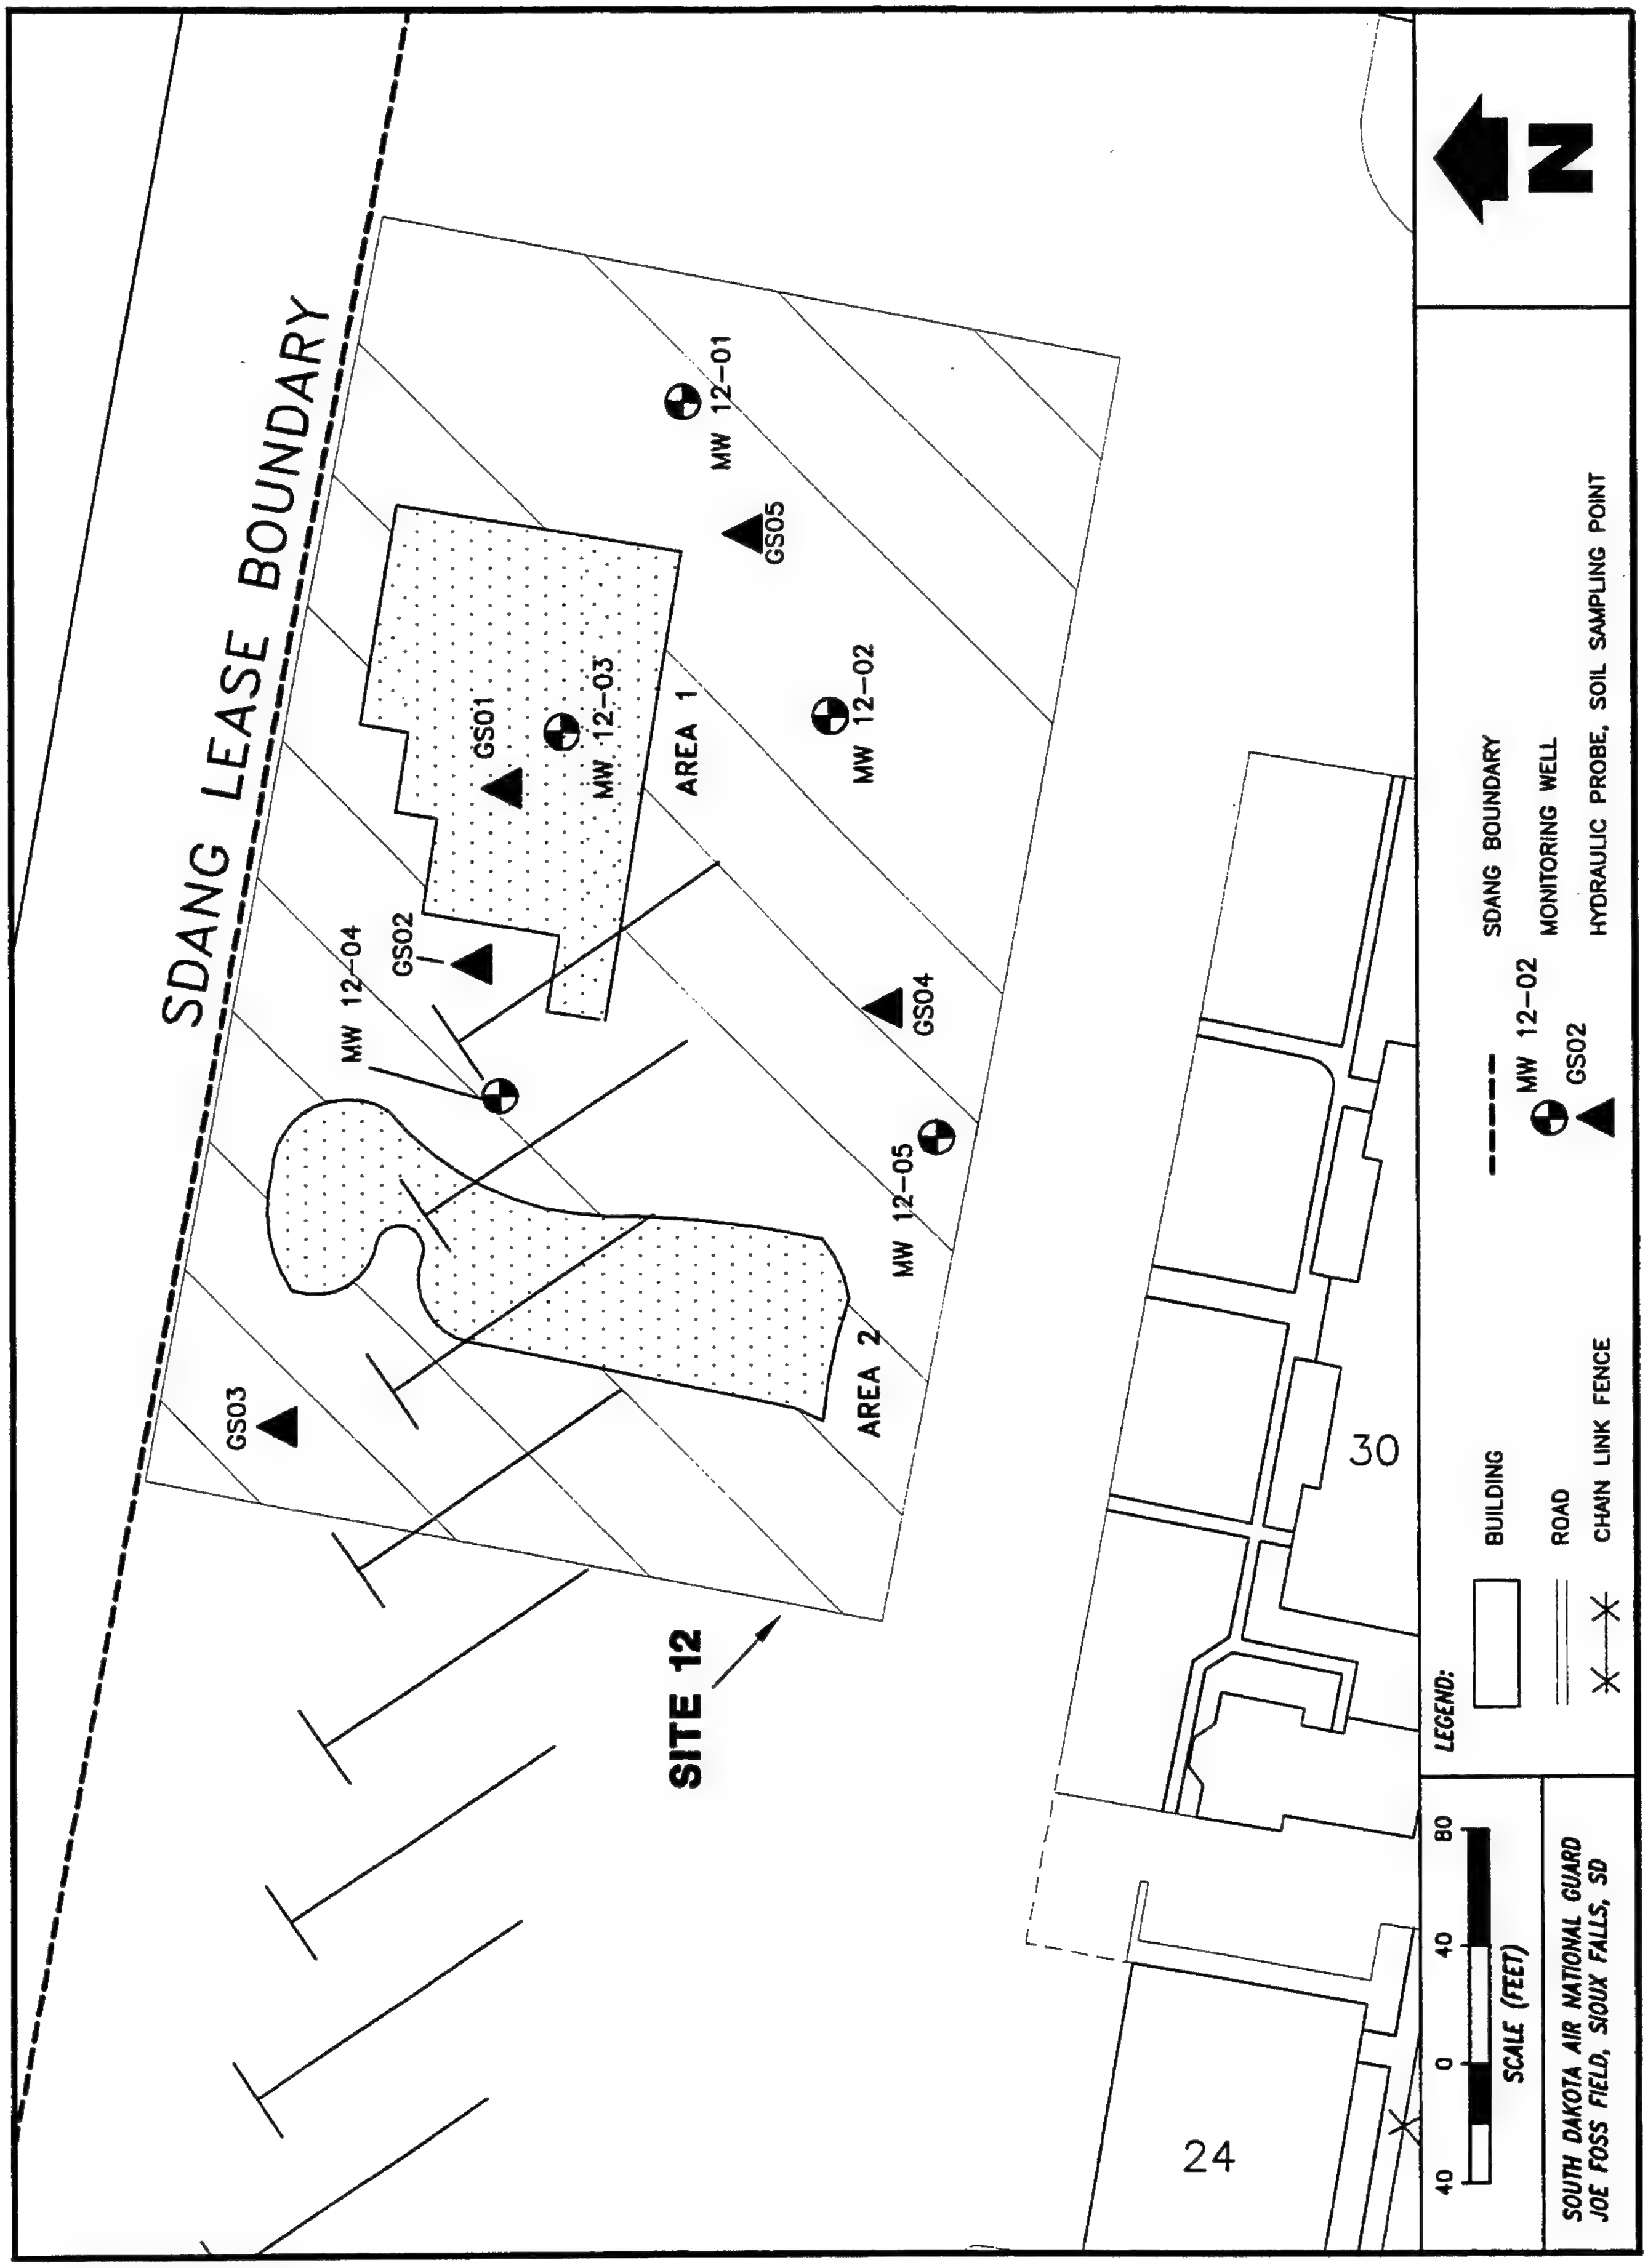
Figure 4-2. Sampling Points at Site 12

Based on the findings of the SOV survey and the historical groundwater flow direction, five soil sampling points were located at Site 12, as shown in Figure 4-2. Soil samples were collected as described above, at 2-foot intervals until groundwater was encountered (2 to 4, 4 to 6, and 6 to 8 feet BLS). The 0- to 2-foot interval sample was not collected because concrete (up to 16 inches thick) and the underlying gravel occupied this entire interval. One soil sample was collected at each interval for screening by the onsite laboratory. The screening data were used to select samples for analyses by the offsite laboratory. Two samples from each of the five locations were sent to the offsite laboratory (10 soil samples total at Site 12). Soil results for Site 12 are presented in Section 5.1 and Appendix A.

Groundwater screening samples were collected for offsite laboratory analysis of BTEX and TPH. Temporary well points were installed at the same five sampling locations used for soils (Figure 4-2). Samples were then collected as described in Section 4.2.4. Five groundwater samples and a duplicate were sent to the offsite laboratory. Site 12 groundwater screening results are presented in Section 5.1.

Five wells were installed at Site 12, both downgradient and upgradient of the suspected contaminant source areas and the excavated Areas 1 and 2 (see Figure 4-2).
